## SOFT-TISSUE AND BONE LOCAL REACTION TO ORTHOPAEDIC IMPLANT - CASE PRESENTATION

**Abstract.** Orthopaedic implants are used at a large scale both for trauma and elective surgery. The components of the implant undergo corrosion and produce metal debris, which can trigger an immune response, depending on the amount and duration of the exposure, which can interfere with the normal healing mechanism, generating local complications. We present the case of a patient who suffered a distal femoral fracture, initially operated with a Dynamic Condylar Screw. Five months after the operation, the fracture did not heal, with an obvious persistent fracture line and malalignment of the fragments, so revision surgery was indicated. Intra-operative evaluation revealed local reactive lesions; and the histological exam showed chronic inflammation with many histiocytes, loaded with metal pigment, multinucleate giant cells and bone lamella evolving into sequestra, therefore confirming that the local reaction to implant contributed to the healing disturbance.

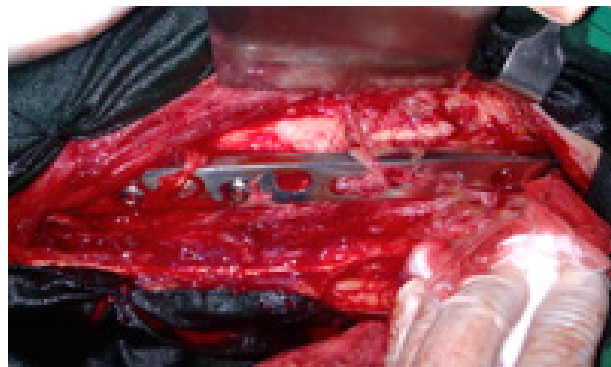
(a)

Intra-operative aspect (Figure 3) before implant removal reveals:

- fibrous membrane around the implant
- reactive tissues in the non-occupied wholes of the plate
- free space between the main fragments, with abnormal movement.

**Fig.3.** Local aspect of the peri-implant tissues, fibrous membrane and reactive tissue around the implant and free space between fragments (a); local aspect after the implant was removed, the free holes of the plate have been filled with fibrous tissue (b)

The treatment consisted of: debridement with excision of the fibrous tissue and avascular structure, cleaning of the free parts of the fragments, so as to ensure the fracture site with vascularized tissues, proper reduction, so as to assure the normal angles and rotation

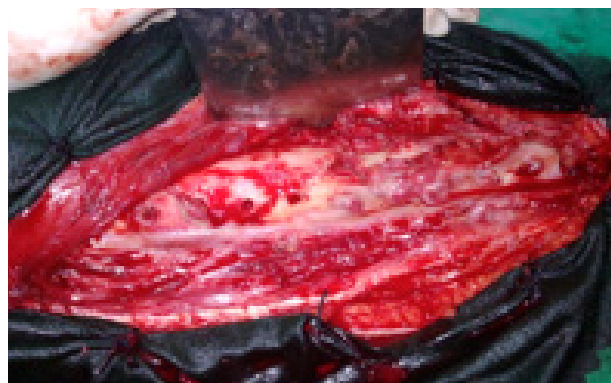
(b)

The implant was removed (Figure 3b); the fibrous membrane became obvious, and also the reactive tissue, which was removed and analyzed histologically: fibroconnective membrane which surrounds bone lamella with different lesions, from dystrophic lesions to bone sequestra and granulomatous reaction with giant cells and histiocytes with metal pigment in their cytoplasm.
